THULE, NORTH RIVER BRIDGE

Kjeld Thomsen, Man.Dir., Christian Riis Petersen, Associate
ISC Consulting Engineers A/S, Copenhagen, Denmark.

NSCC, Copenhagen 2004

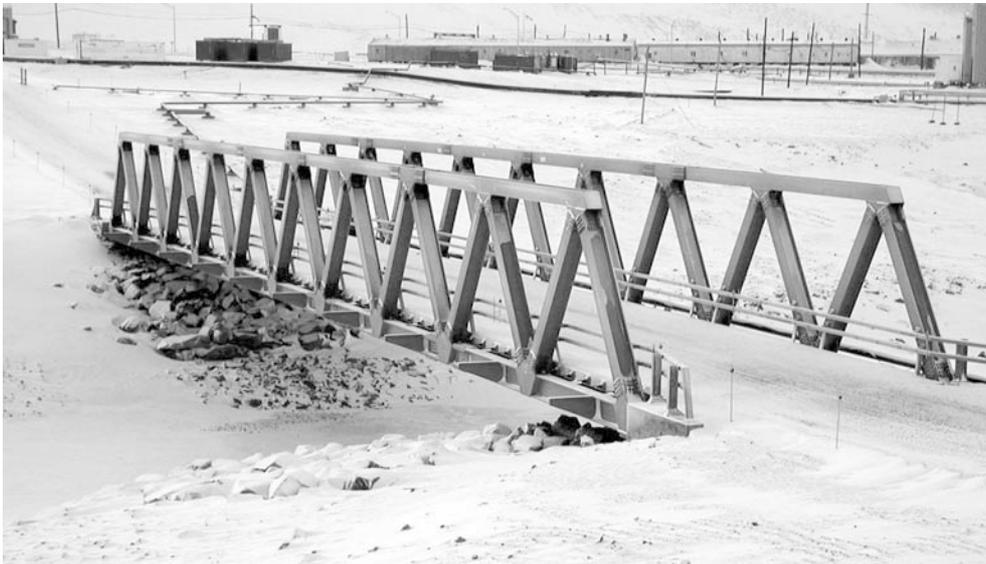
Fig. 1: View of completed bridge

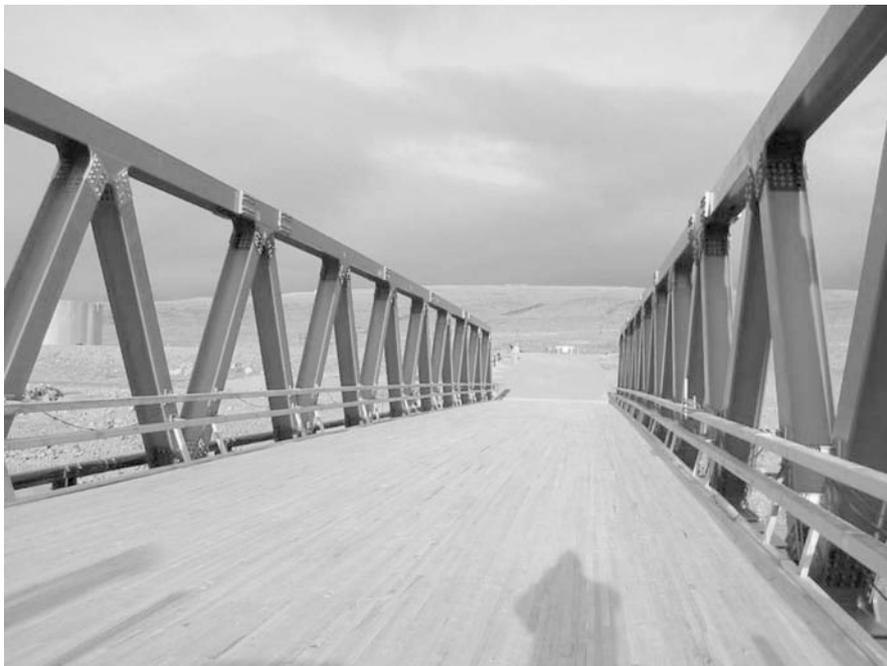
Fig. 11: Inside view of completed bridge

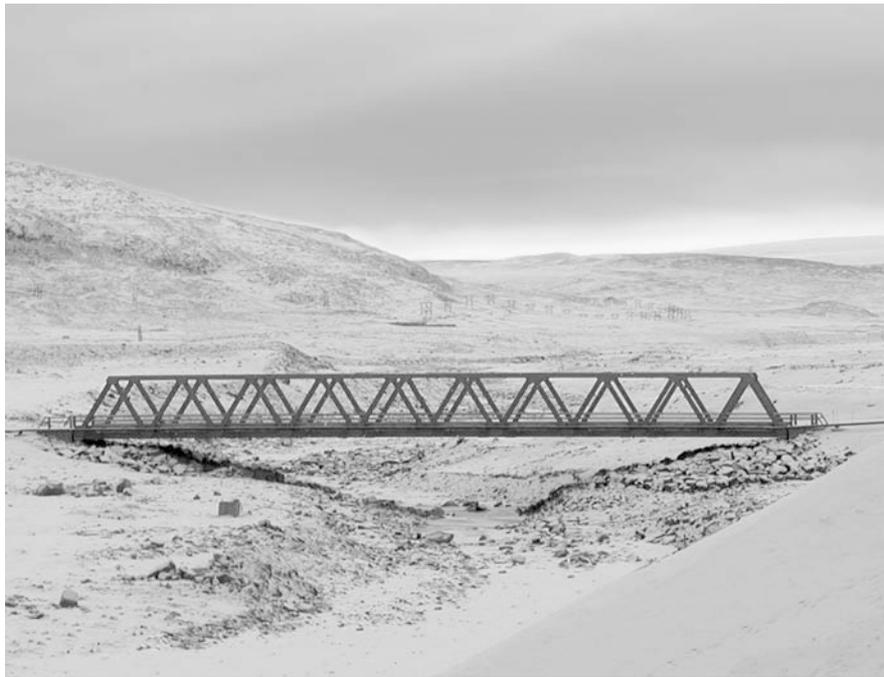
Fig. 12: Front view of completed bridge
